PISMO BEACH COUNCIL AGENDA REPORT

A RESOLUTION ACCEPTING AND FILING THE DESIGN CONCEPT PROVIDED BY HAMRICK AND ASSOCIATES FOR THE FEASIBILITY ASSESSMENT OF THE OLD CITY HALL

Project No. 10-0024
September 16, 2011

**PISMO GRAMMAR SCHOOL BUILDING
FEASIBILITY ASSESSMENT**

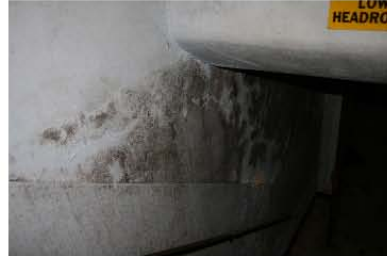
An inspection in 2003 noted the presence of water damage and mold in the basement. Current inspection confirms the presence of fungal contaminants in the walls, carpet and ceiling of the entire building. Fungal damage was also noted at the eave overhangs in the pest report.

The source of water infiltration appears to be from the roof. Another source could be from the retaining walls in the basement. These walls are likely sealed with tar from the outside and, over time the tar will have a tendency to become hard and brittle. As the tar cracks, it allows water to penetrate the membrane and infiltrate the structure.

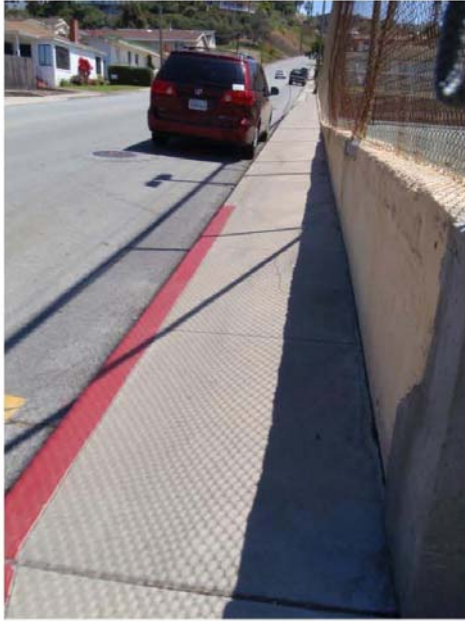
There is limited pedestrian access to the site because of insufficient curb ramps, clearances and cross slopes. The existing ramps need replacement to correct the trip hazards and lack of warning devices.

Sidewalk on southerly side of Wadsworth Ave. adjacent to tennis courts

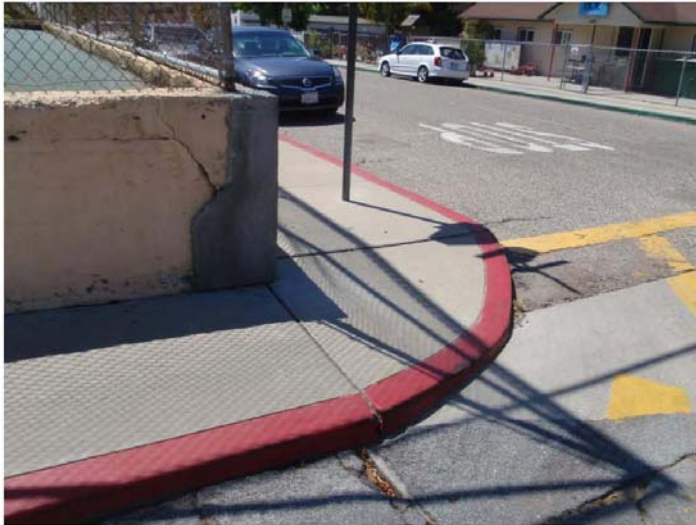
Curb ramp at Wadsworth and Bello Avenues

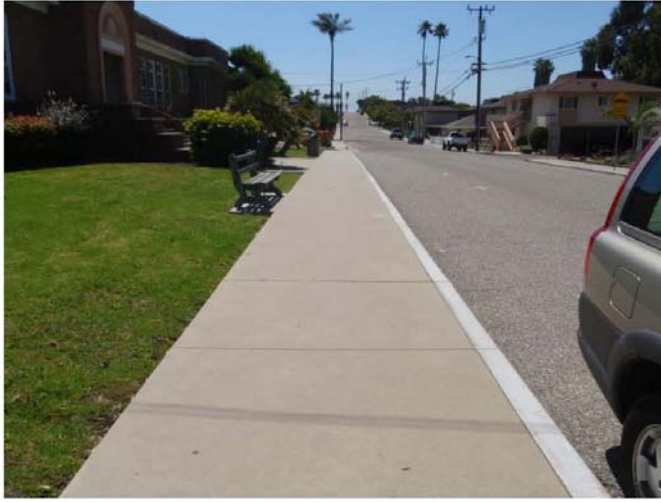
Sidewalk on easterly side of Bello Avenue

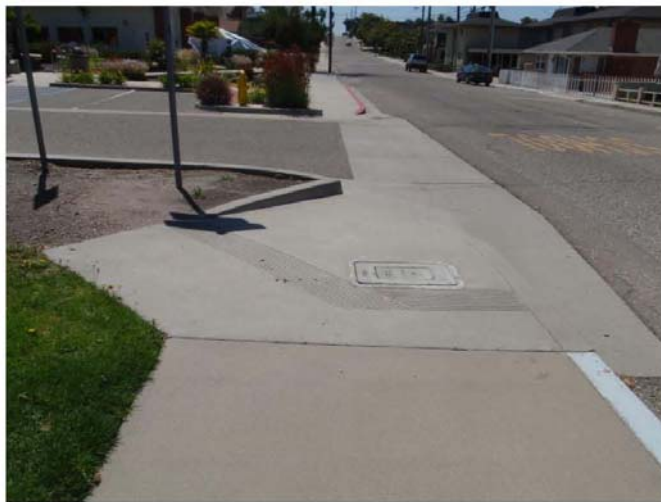
Curb ramp at police station driveway

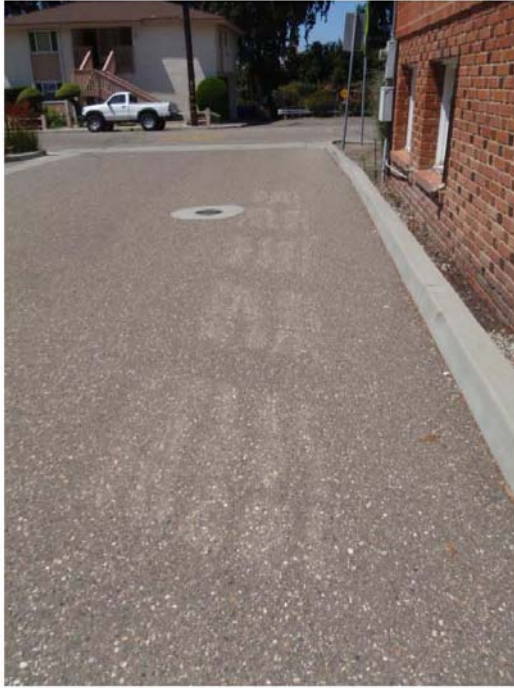
Police station driveway looking west toward Bello Avenue

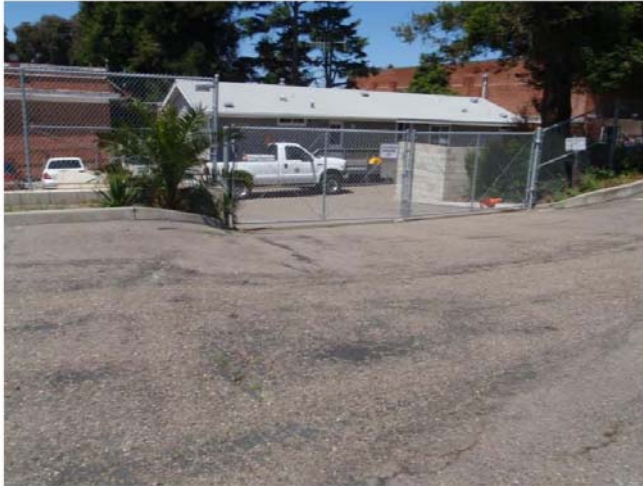
Asphalt ramp and temporary building at rear of project

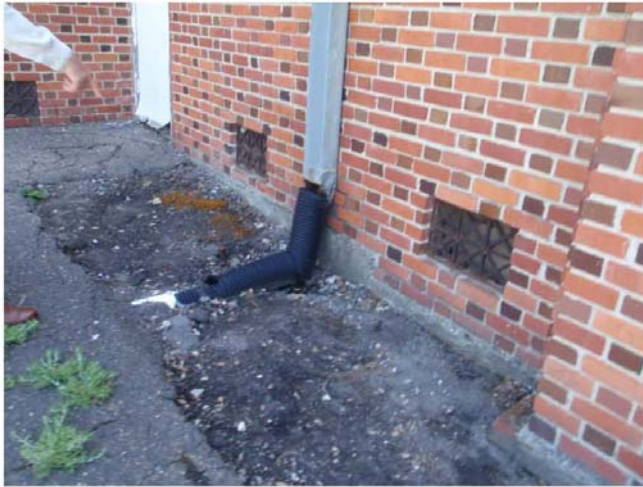
Roof drain leaders have been retrofitted to allow for underground run off. With lack of maintenance, the connections do not function as designed and the water spills out onto the ground adjacent to the building foundation. This configuration could damage the foundation as the soil expands and contracts with hydration.

Downspout on northerly side of building

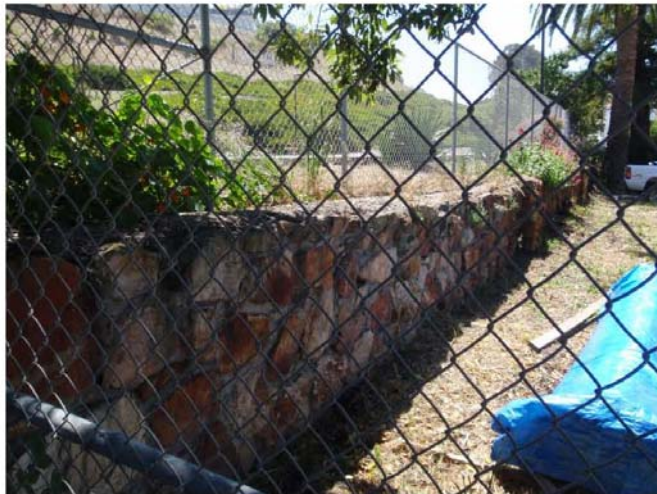
The retaining walls around the tennis courts are cracked and show signs of damage due to water intrusion. The walls should be replaced prior to failure, especially if the sidewalks need to be brought up the HC standards. The stone retaining wall behind the building and along the northerly property line is failing and not designed per current regulations.

Retaining wall at rear of property

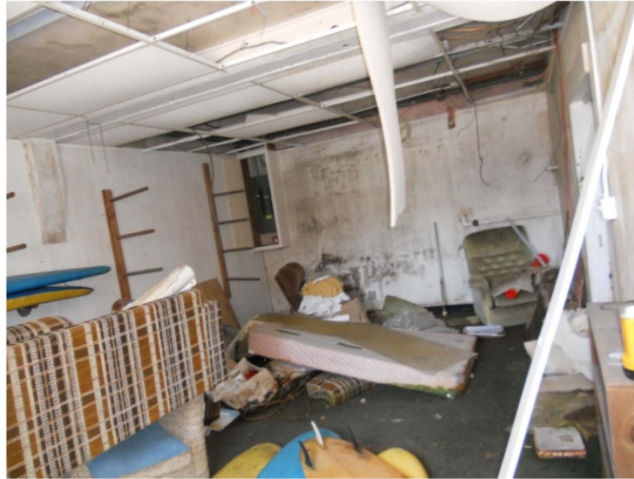
Photo #1 Caption: Basement – far right room (cement walls, ceiling tiles, plaste ceiling

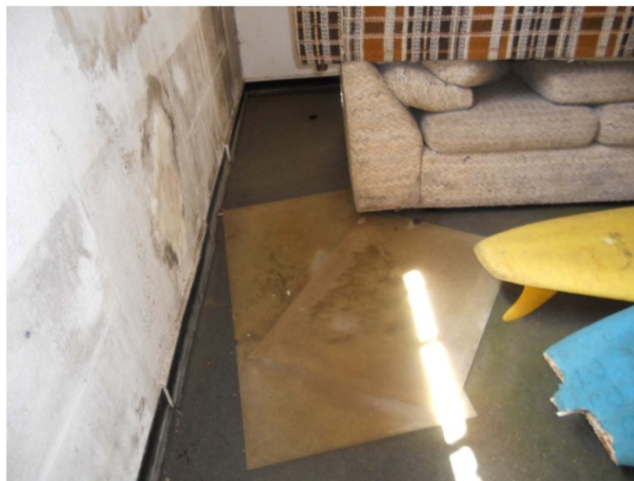
Photo #2 Caption: Interior wall with suspect mold and carpet

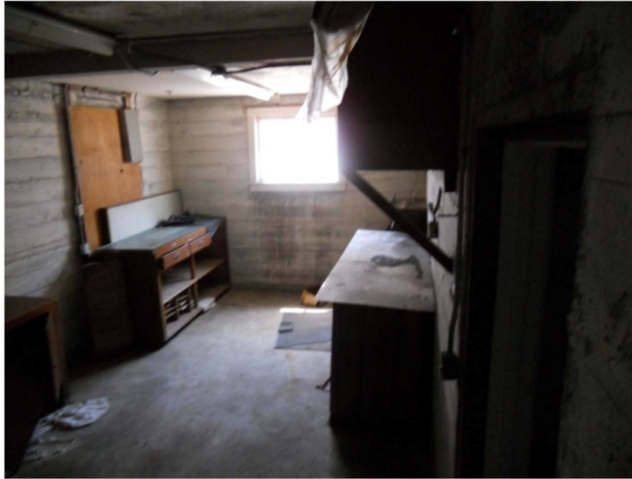
Photo #1 Caption: Basement – far left room

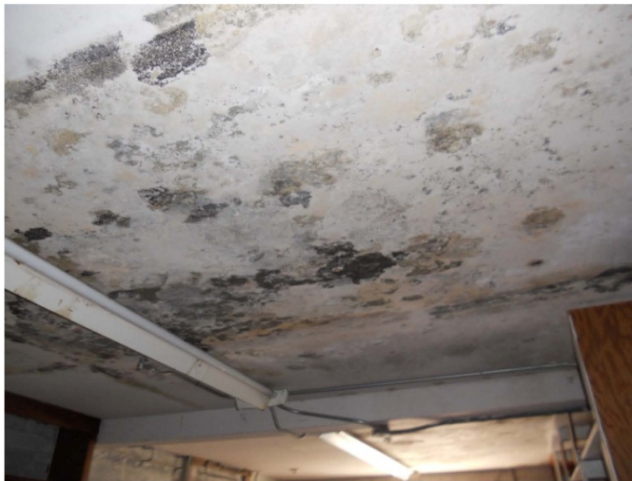
Photo #2 Caption: Basement – far left room - ceiling

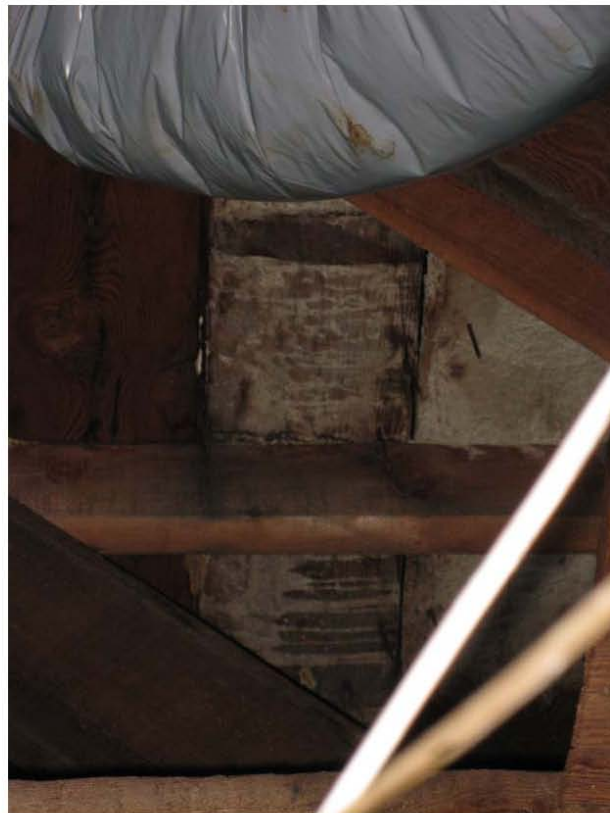
Figure 1 – Mold and Dry Rot at Roof Framing

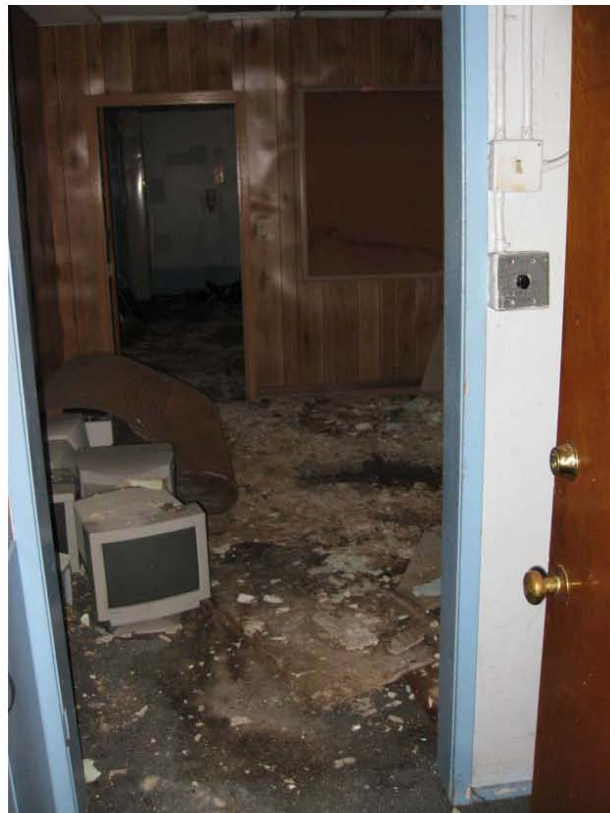
Figure 2 – Saturated Carpet

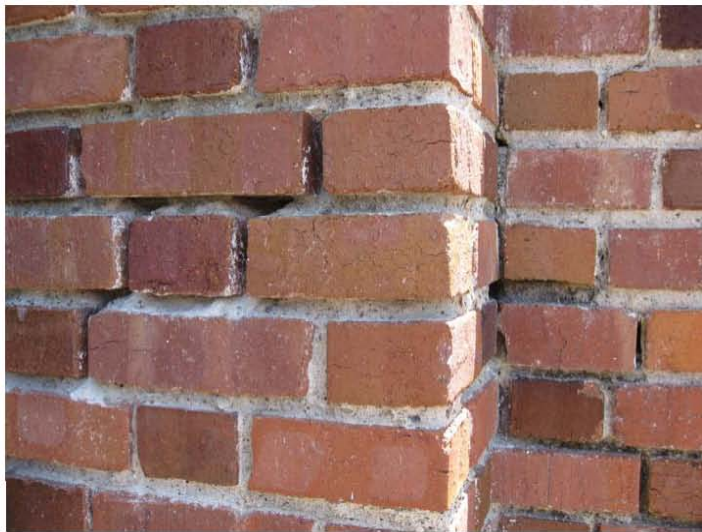
Figure 3 – Deterioration in Mortar

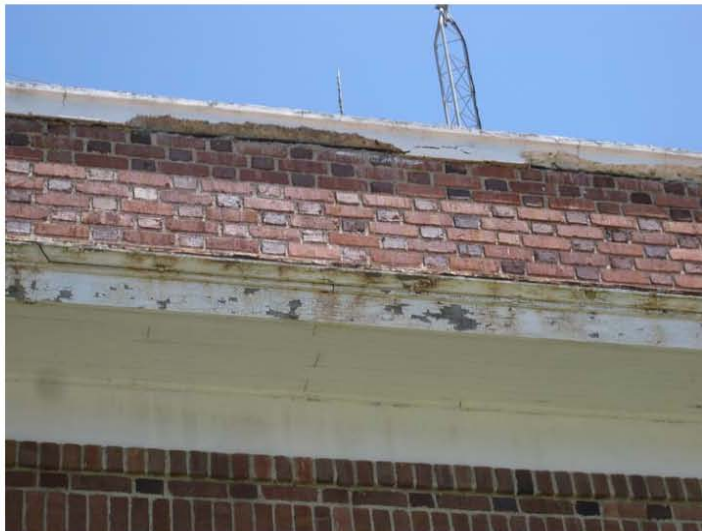
Figure 4 – Spalling Concrete and Exposed Rebar at Cornice

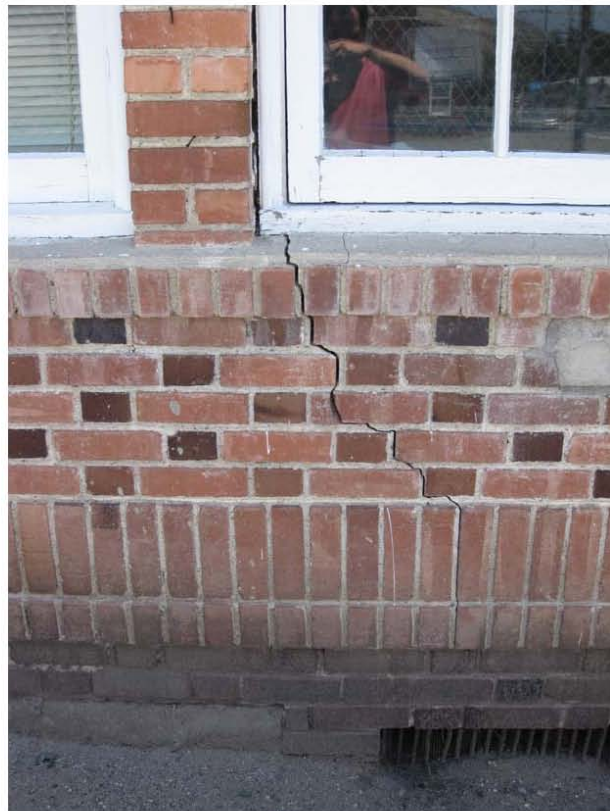
Figure 5 – Crack Near Southwest Corner

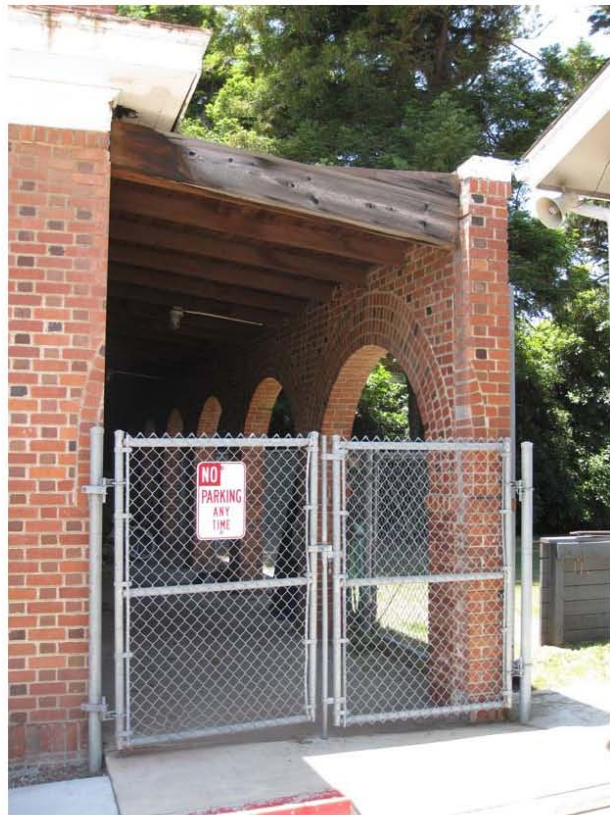
Figure 6 – Location of Previously Removed Damaged Arch

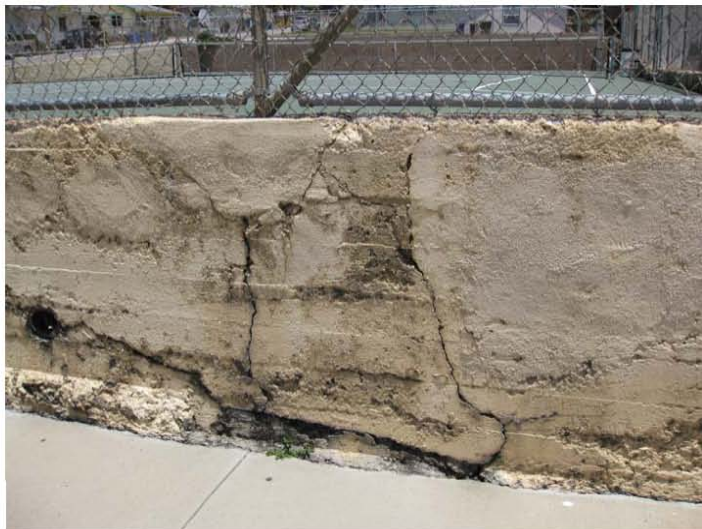
Figure 7 – Cracks in Tennis Court Wall
