PISMO BEACH COUNCIL AGENDA REPORT

A RESOLUTION ACCEPTING AND FILING THE DESIGN CONCEPT PROVIDED BY HAMRICK AND ASSOCIATES FOR THE FEASIBILITY ASSESSMENT OF THE OLD CITY HALL

Project No. 10-0024
September 16, 2011

**PISMO GRAMMAR SCHOOL BUILDING
FEASIBILITY ASSESSMENT**

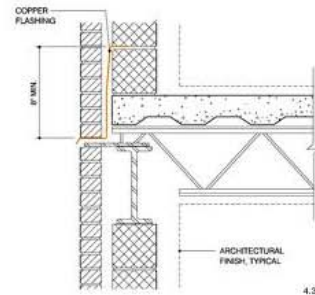
The building was abandoned because it was a URM (un-reinforced masonry) building. Steel, the key component of masonry buildings, was not commonly used in masonry walls until the 1930's. As structures collapsed during earthquakes, it became common practice and a requirement later.

The roof and floor were constructed out of wood. The roof framing is generally in moderate condition. Any damage at this level was the result of roof leaks, termites or dry rot. It is estimated that 30% of the roof sheathing and trusses will need to be replaced.

The floor framing is damaged as a result of water intrusion. Water infiltration from roof leakage has been allowed to soak in the carpet and floor sheathing below. It is estimated that 50% of the roof sheathing and trusses will need to be replaced.

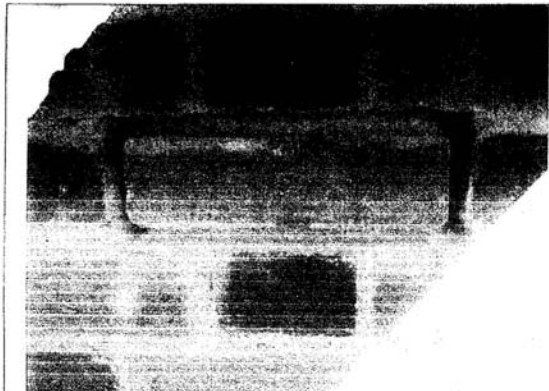
Figure 2: Prepared Test Area

Mortar joints were removed from either side to the brick to be tested (See Figure 2: Prepared Test Area). Flatjacks (See Appendix A for Flatjack Specifications) were inserted into the cleared joint on one side of the brick and then connected to a hydraulic pump (See Figure 3: Flatjack Shear Testing). Hydraulic fluid was pumped into the flatjack to a maximum flatjack operating pressure of 1000 psi and mortar joints were inspected for deformations. Test location number 5 showed a hairline vertical crack along the bottom mortar joint but did not cause the brick to break away from the bedded mortar. No physical deformations were observed in the bedded mortar for all other tests.

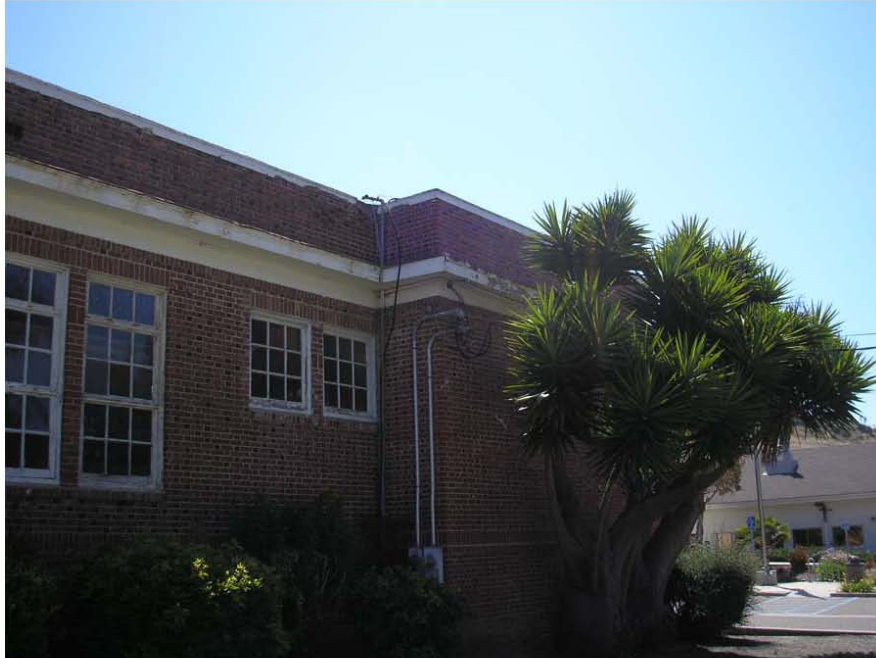
Exhibit A

The picture attached depicts to two small existing electric services, with the third in the background; exhibit A.

What ever re-use of this building may be considered; I would demolish and rebuild the current electrical system. It is currently supporting the Office trailer in the rear for Cal Fire.
